Post Construction Long-Term Maintenance Annual Inspection Report 331 Premier Court - Permit FSW-05-038

The site was inspected September 19, 2008 to determine the presents and status of post constructions stormwater best management practices associated with this site:

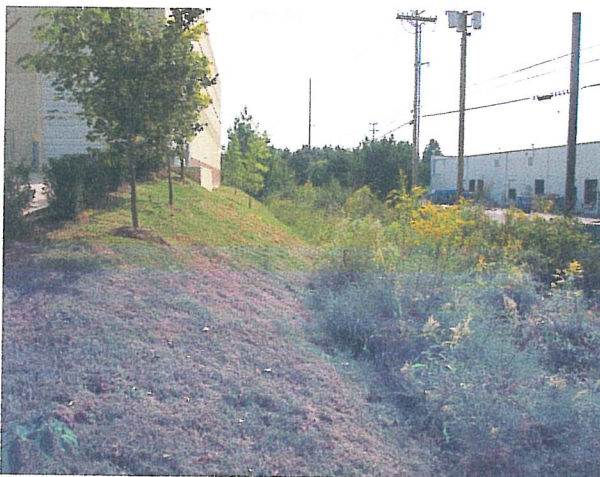
Swale: Facing east (from back of building to front)

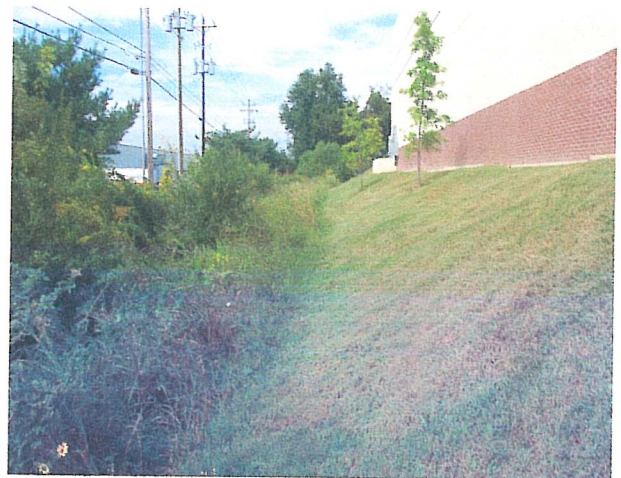
Swale facing west (from front to rear)

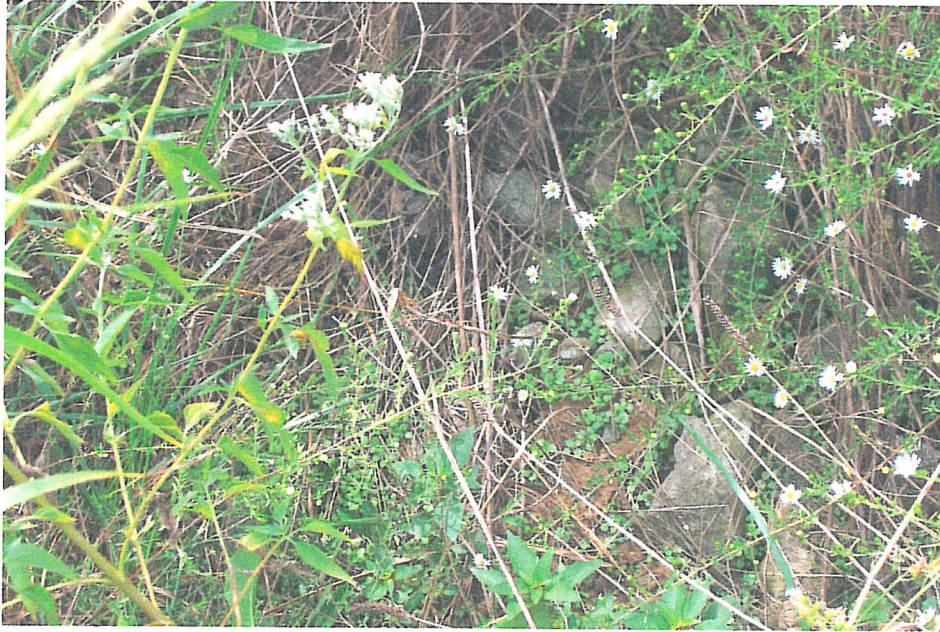
Bottom of swale near energy dissipating headwall

The swale has been allowed to grow up naturally with weeds, some grasses, golden rod, willow and other small bushes and trees. As you can see in the above picture, which is common along most of the swale associated with this site, the bottom is lined with small rip rap. The bottom of the swale does not receive regular maintenance, but does seem to be relatively stable. The swale also drains sections of the commercial development north of this site. As it leaves the site, persisting towards the detention, it becomes much deeper and wider from about 3 – 4 ft deep, compared to the south bank, to 5 - 6 feet deep.

The site is stable. The swale has been allowed to grow naturally without any inspection or maintenance. The bottom of the swale is lined with small stone/rip rap and does not appear to be a source of sediment to the off site regional detention.

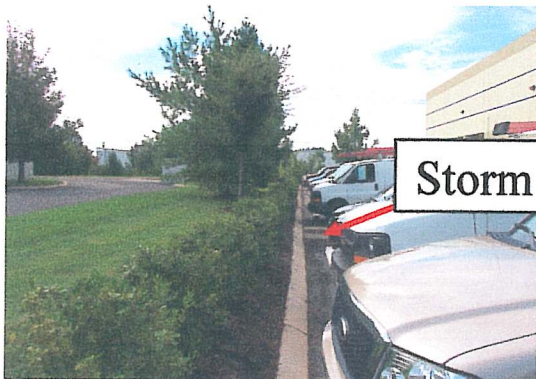
3) **Storm drains:** They appear to be well maintained

Storm drain on east side in car parking lot. It drains the entire parking lot.

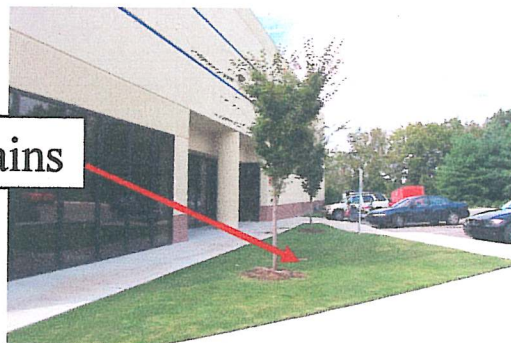
Storm drain on north side of building. It drains the small green area.

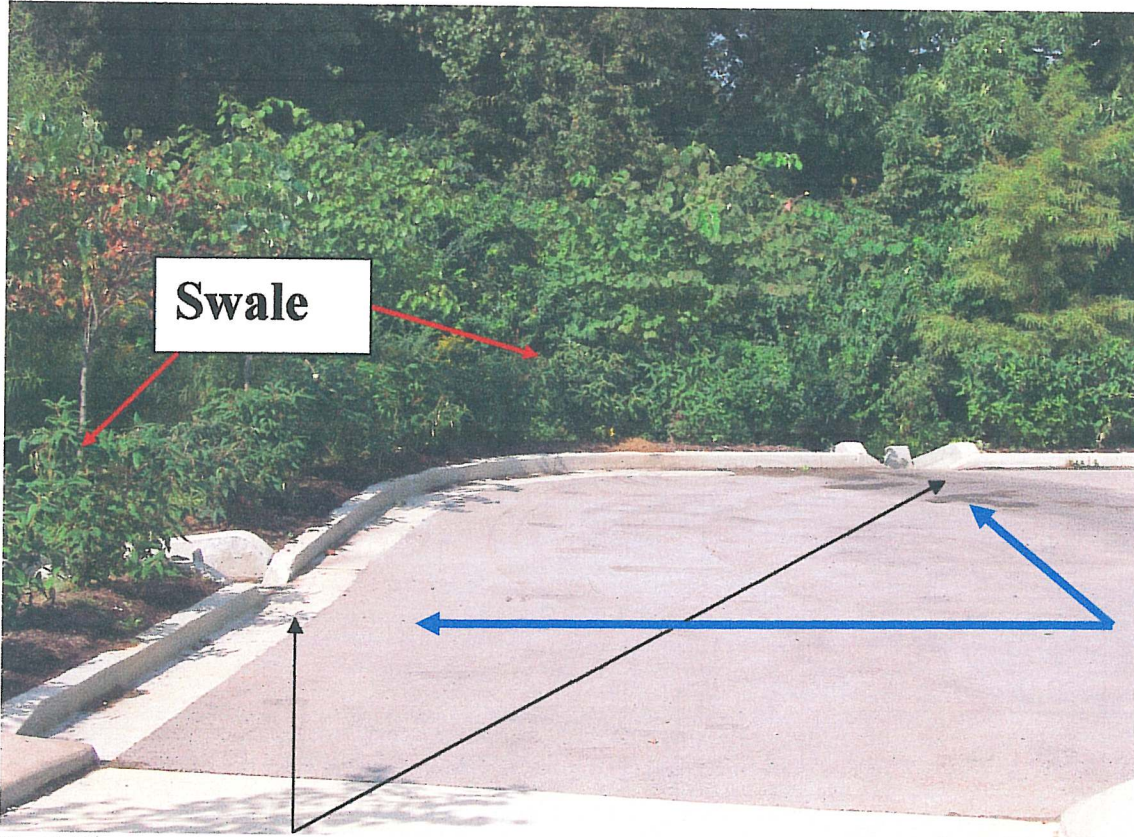
4) **Energy dispending Outfalls:** Two out falls are located at the south west side at the rear of the building. They capture the truck parking area and roof top. The out falls go into the swale which takes the water from west to east into a common detention pond off site.

Outfalls at south west corner of building, facing west, receiving flow from rear of building and roof.

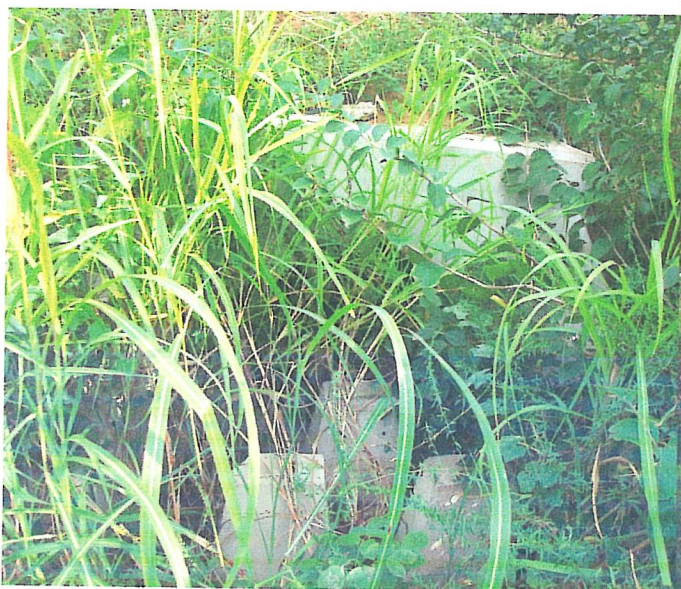
Energy dissipater Headwall outfall facing north

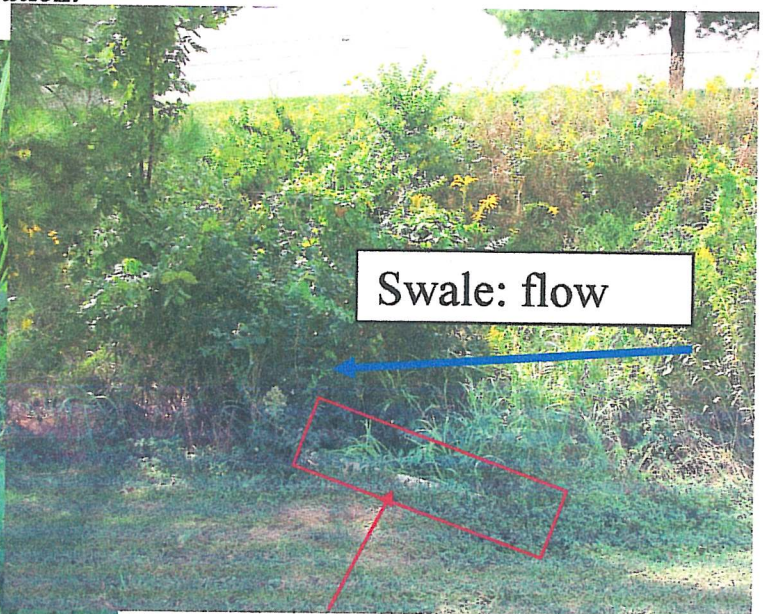
Top of outfall facing south into swale
