ITEM #10  
WRK S 02/09/10

Attachment F:  
Harlinsdale Photos

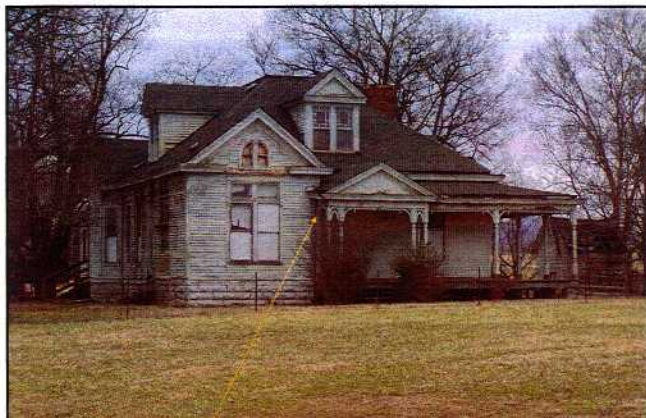
Front porch has settled and a lot of the trim has separated. This has allowed weather to cause dry rot of gutter boards, framing and soffits. This separation from settling has happened all the way around the home.

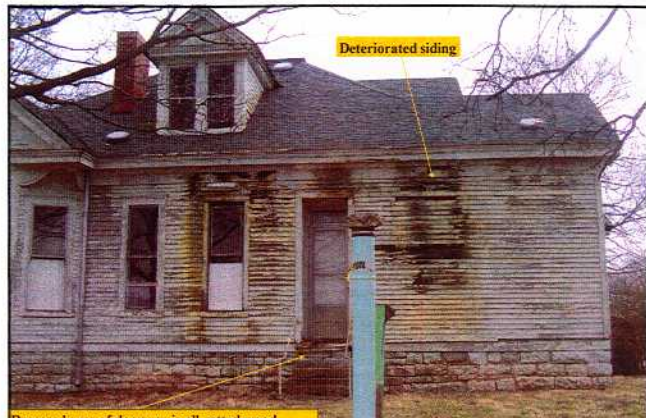
Deteriorated siding  
Recessed area of doorway is all rotted wood. Approx. a 3'x3' landing.

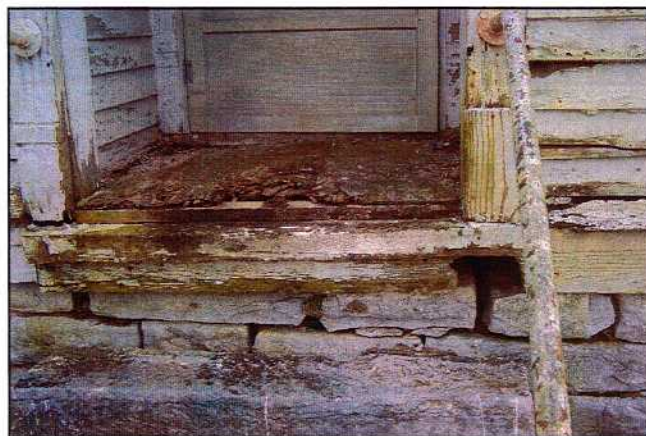
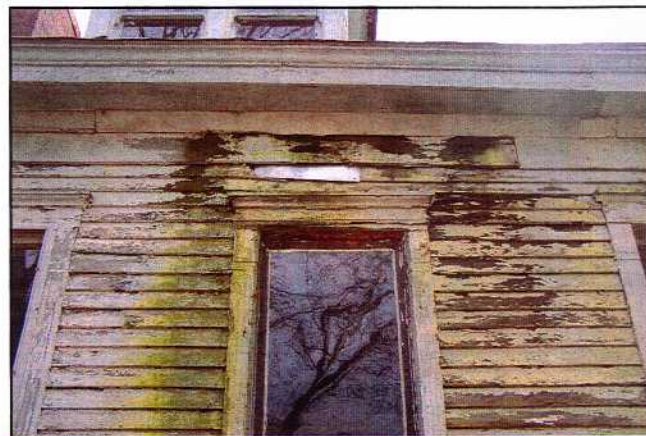
Most of the outside and inside damage was caused from the gutter system leakage over years

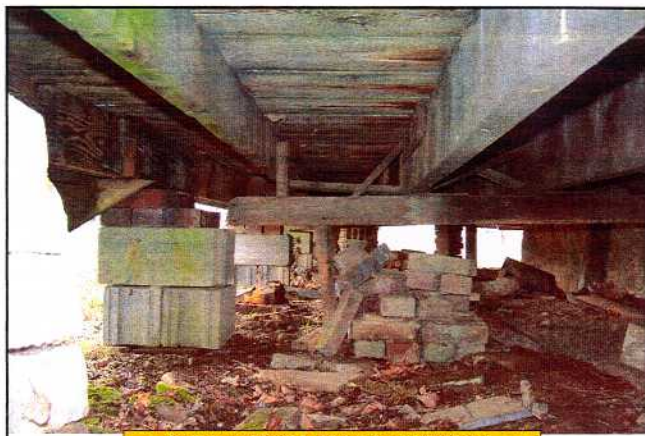
Entire wrap around porch is poorly supported.

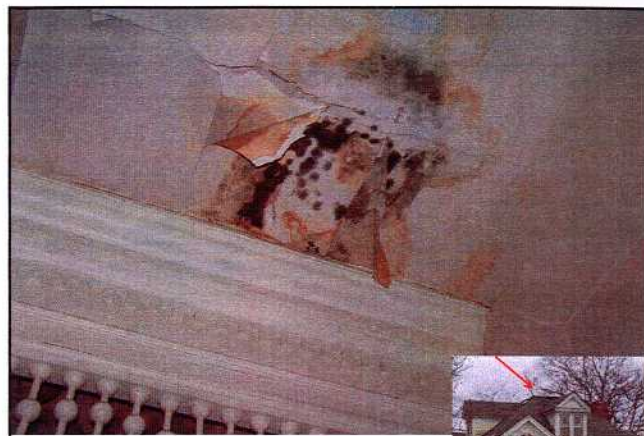
Center of house- Caused by Widow's Peak leaking
