HISTORIC
FRANKLIN
TENNESSEE

SUBJECT: Notification of approval for the demolition of the Historic Power House.

Re: Harlinsdale Park Power House Storm Damage
331 Franklin Road

Re: Storm Damage Repair
The Park at Harlinsdale Farm

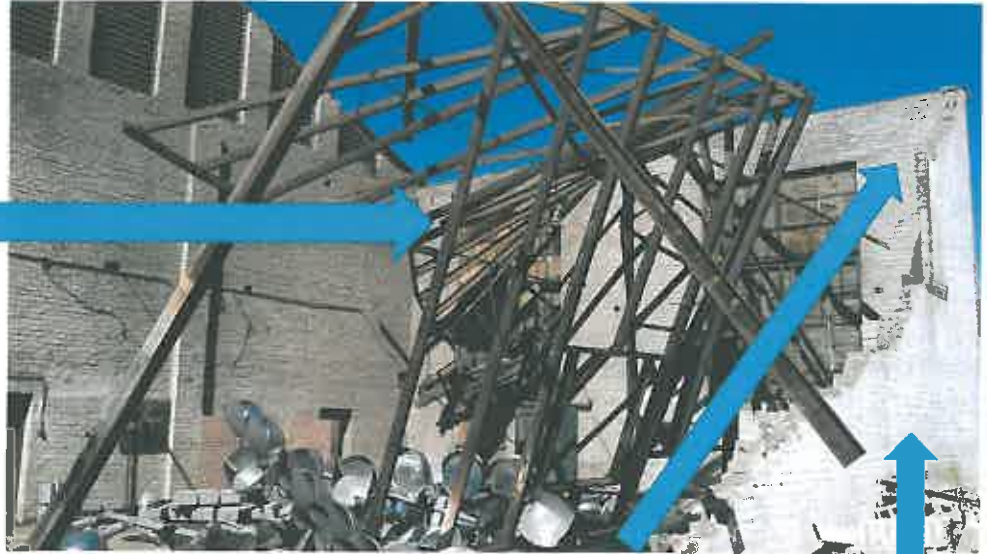
Red iron
damaged
beyond repair.

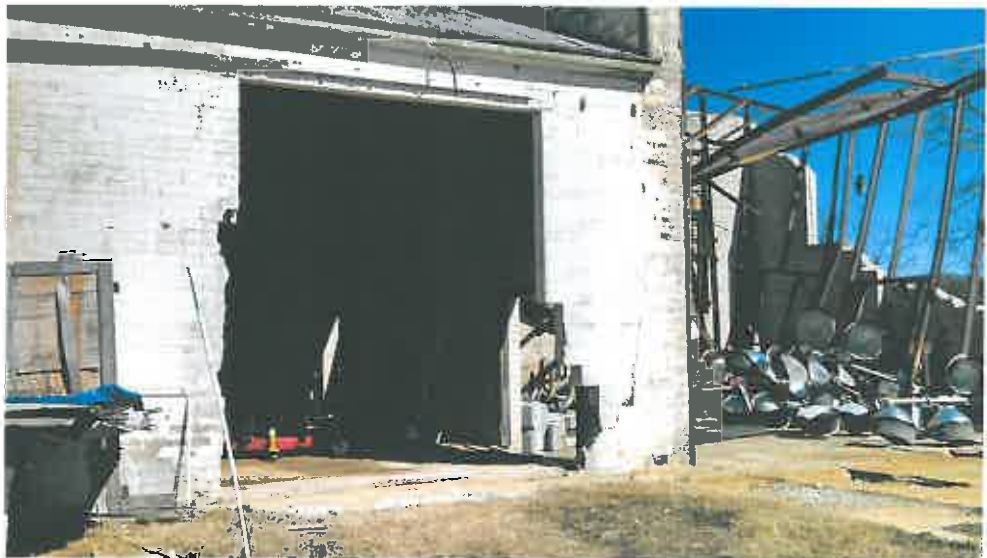
Damaged walls to be removed. Photo shows both damaged walls to be removed.

Use fallen brick material to fill in opening in wall that was cut out to allow storage for farm tractor. Wall is not structurally sound, needs support reinstalled.
