HISTORIC  
FRANKLIN  
TENNESSEE

**SUBJECT:** **Amendment No 1 to Smith Seckman Reid, Inc (SSR)  
Professional Services Agreement for Maintenance of  
The Stream Gauging Stations**

# Memorandum

**DATE:** May 12, 2010  
**TO:** File  
**CC:**  
**FROM:** Bo Butler  
**RE:** **FRANKLIN STREAM GAUGE STORM DAMAGE EVALUATIONS**  
SSR No. 09-41-018.0

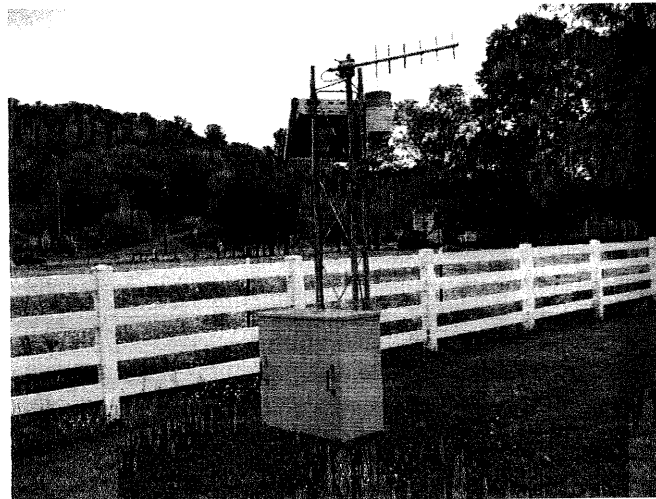
Solar-Powered Rain Gauge at Dry Branch

Dry Branch Station was not affected by the flood waters. Water from Dry Branch and the stormwater detention facilities did not reach the datalogger enclosure nor the rain sampler, and that station appeared to be operating as it should.

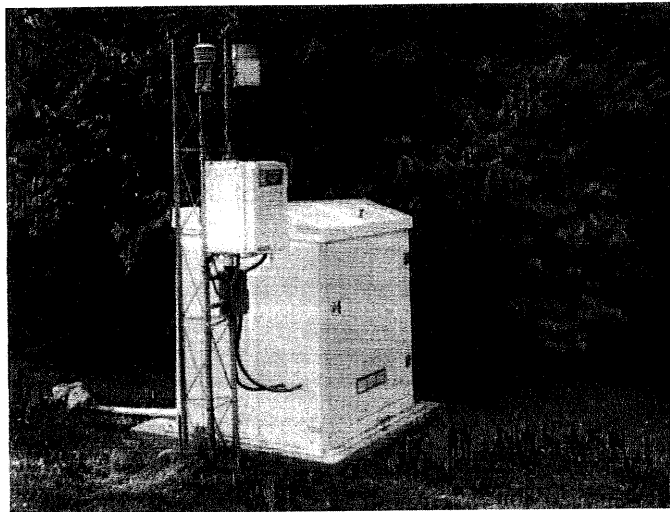
The Liberty Creek Station did not sustain any noticeable damage in this rain event and all systems are working properly. When the water level in the creek recedes, additional inspection of the bubbler and sampler lines will be needed.

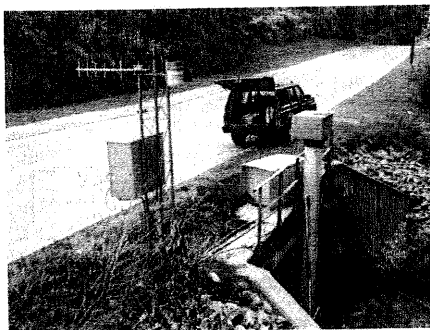
Sharpe's Branch Station

The Sharps Branch Station appeared to be flooded under approximately 8 feet of water according to the high water marks in the area. The sampler was broken loose from its moorings, the power lines and sampler lines were broken as well as the conduit that held these lines. The sampler was inundated and the control head was submerged as well as the power and instrumentation box within the all-weather refrigerated sampler. It appears as though this sampler will not be able to be repaired in a cost-effective manner and will need to be replaced along with the associated power and water lines and conduit.

The all-weather box that contained the electronics for the Sharps Branch Station was also completely submerged. A lot of water got into the box, inundating the cell phone, bubbler, power control box, datalogger and battery. In fact, the rain gauge that is installed approximately 8 feet up on a tower next to the sampler was inundated and mud was found inside the rain gauge. Wires and connections were corroded and mud was found inside the box, as well as the power disconnect box on the tower at the station. This station will not be able to be salvaged and will need to be replaced.

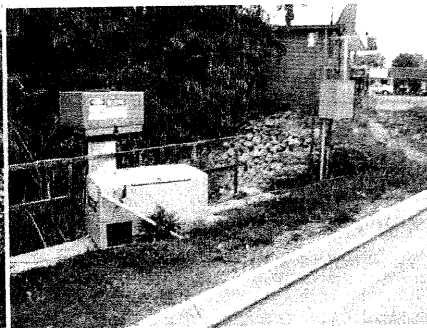
Sampler on its side

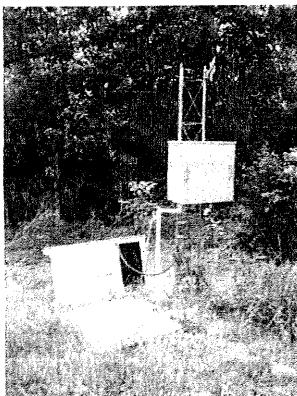
The Spencer Creek Station sustained major damage to the all-weather sampler. It was found down the hill from the original location, held in place by the power lines. Sampler lines and conduit were broken, and the all-weather sampler was submerged in floodwater from Spencer Creek. Water has entered the control head and the compressor, and it appears that it will not be able to be salvaged. The power instrumentation box on the back of the sampler was also inundated with water and all the electronics were exposed to creek water.

The bubbler at Spencer Creek was also damaged and does not appear to be working. The cell phone is operating. Although water entered the PVC enclosure, it appears as though it did not get high enough to damage the charger and the battery. We feel like this station is repairable, although the sampler will need to be replaced as well as the bubbler at this location.

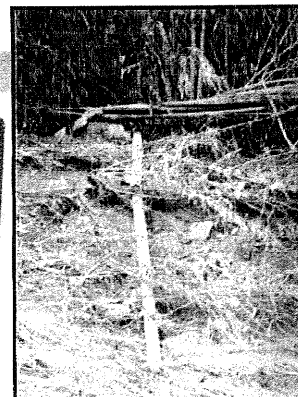
Sampler Line

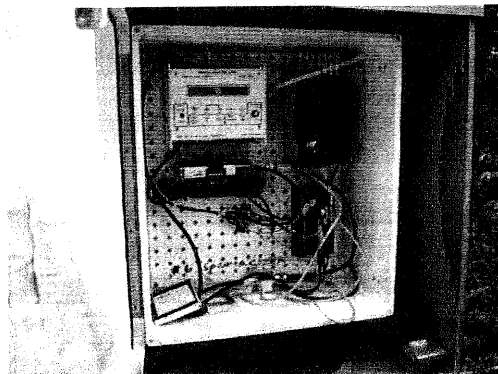
Control Box

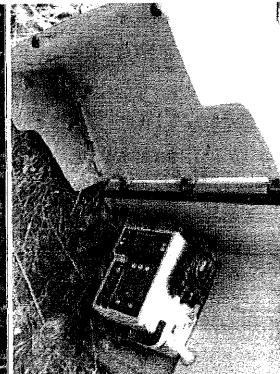
Sampler Head

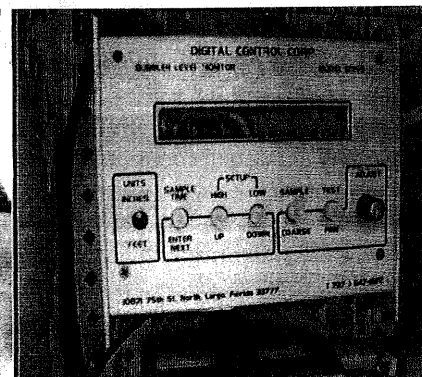
Bubbler Level Sensor

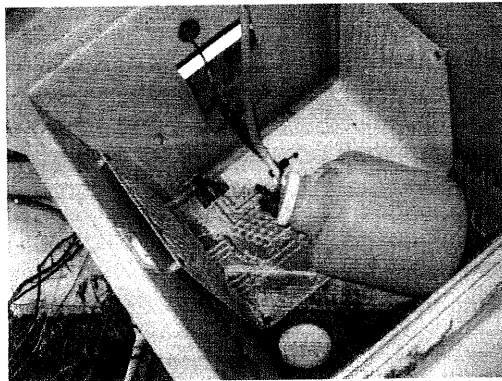
The Arno Road Sampler was partially submerged under the Arno Road bridge. The conduit containing the sampler and bubbler lines was broken, and further inspection will reveal whether this sampler can be cleaned and repaired for future use. It appears as though the control head was not submerged.
