July 2021

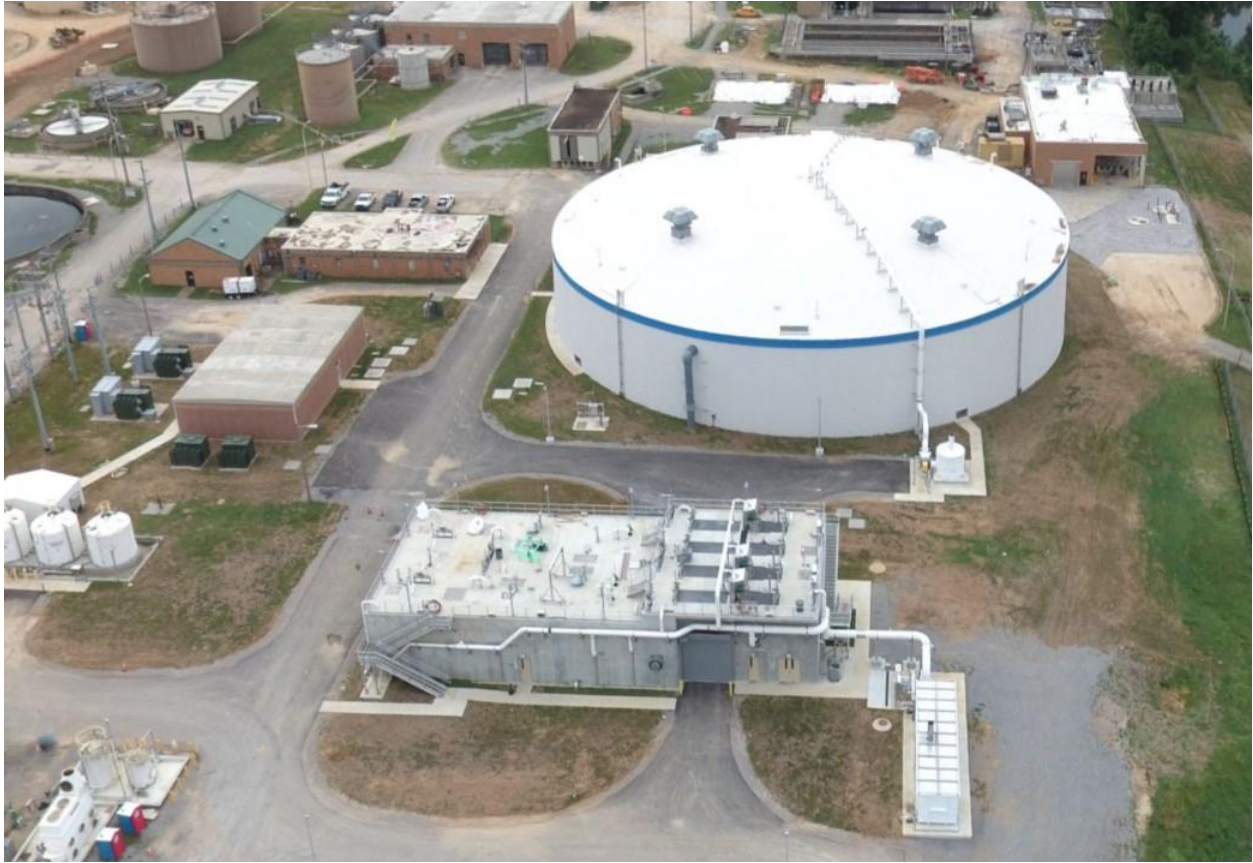
This is an aerial view of the new equalization tank and headworks structure. These structures are finished and working through factory testing of all of the equipment housed inside them. From start-up observations, the headworks is more efficient and removes more debris and grit from the incoming wastewater flow, protecting downstream equipment from the wear and tear of the objects found in wastewater.

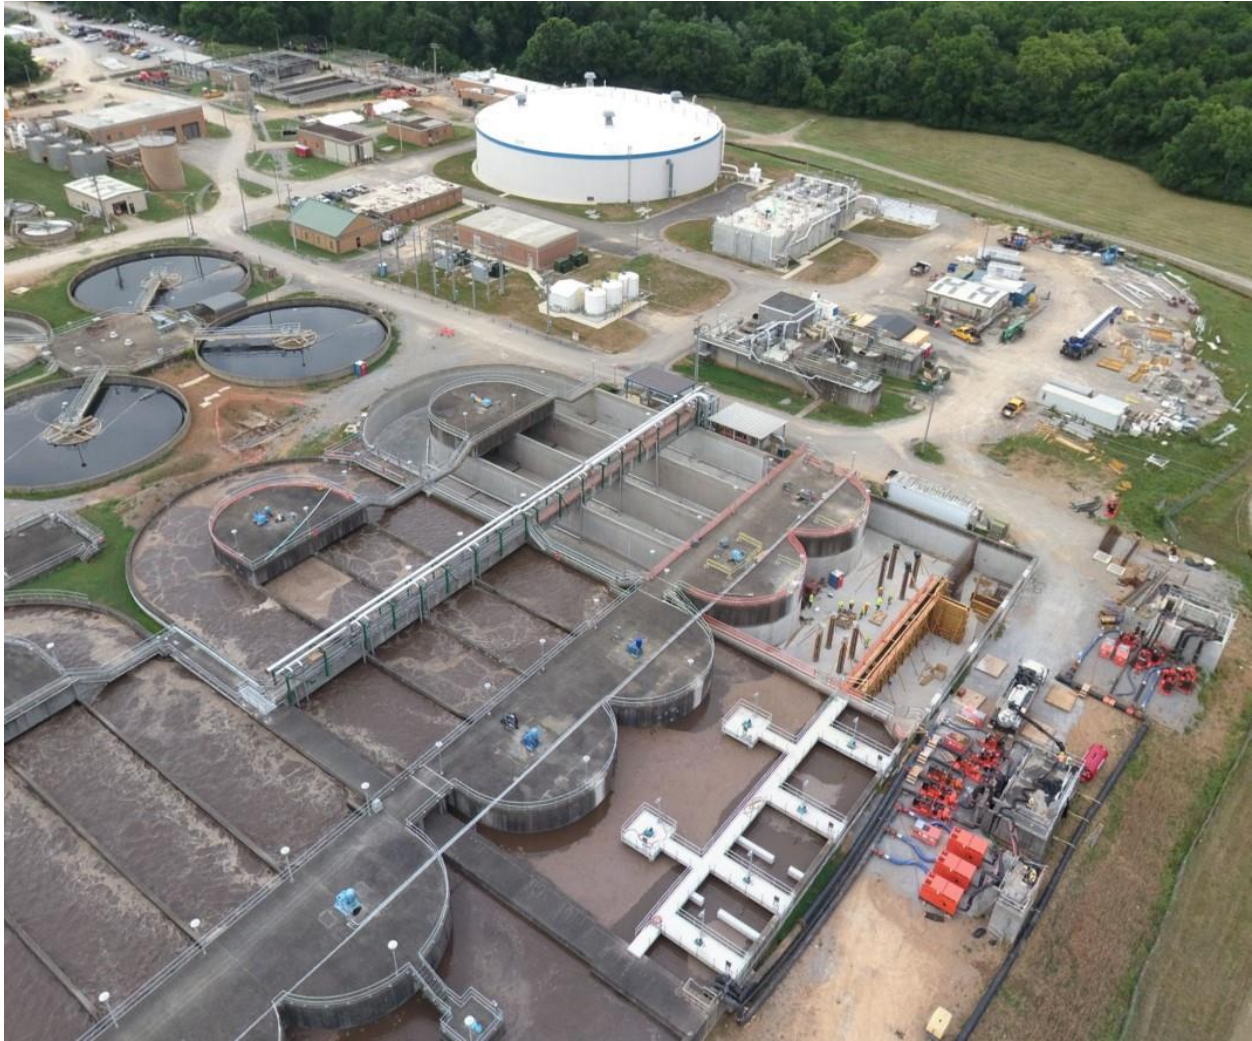
This is an aerial view of the biological nutrient removal basins. Last year you could see work occurring in Basin #2. Since then, work has been completed in that basin and start-up has occurred, and work has now begun in Basin #1. The fermentation zone, the area on the southeast corner of the basins, is the area where increased efficiencies in biological phosphorus removal will occur. We've added mixers and baffled areas to accommodate phosphorus accumulating organisms in this area for increased removal percentages.

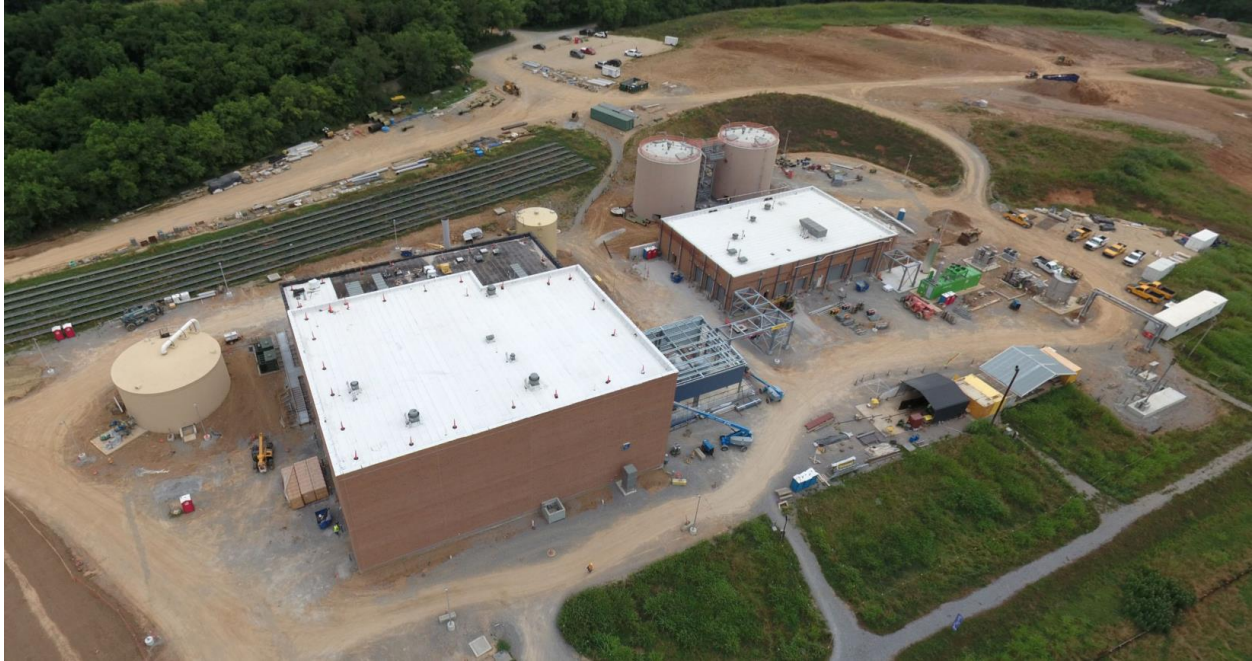
This is an aerial view of the new solids processing area, for direction, the walking trail is to the east of this field. The solids building is the largest building on the left and will house the pre and post dewatering equipment, what will be used to squeeze the water out of the solids before disposing of them. The building on the right is the digester building, the two circular tanks above that building are the digesters. The digesters will stabilize the solids per EPA recommendations. Gas that is produced from the digesters will be used in the green building, the combined heat and power engine, that will turn that biogas into energy and be used back in the facilities grid to offset power costs.
