HISTORIC  
FRANKLIN  
TENNESSEE

**SUBJECT:** **Amendment No 1 to Smith Seckman Reid, Inc (SSR)  
Professional Services Agreement for Maintenance of  
The Stream Gauging Stations**

# Memorandum

**DATE:** May 12, 2010  
**TO:** File  
**CC:**  
**FROM:** Bo Butler  
**RE:** **FRANKLIN STREAM GAUGE STORM DAMAGE EVALUATIONS**  
SSR No. 09-41-018.0

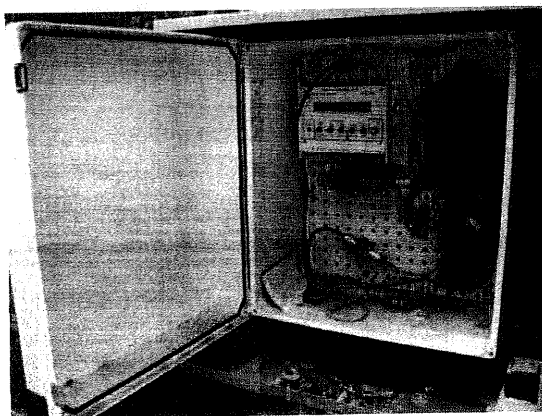
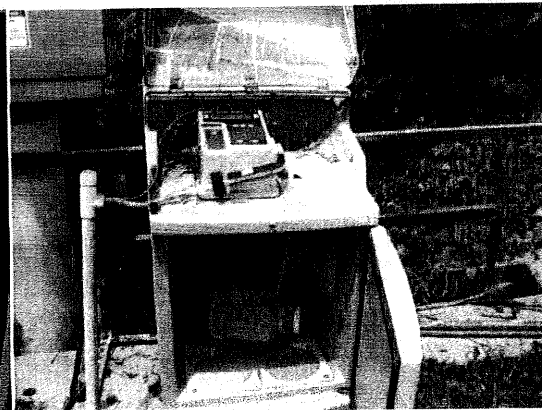
Disconnect

The all-weather box that contained the electronics for the Sharps Branch Station was also completely submerged. A lot of water got into the box, inundating the cell phone, bubbler, power control box, datalogger and battery. In fact, the rain gauge that is installed approximately 8 feet up on a tower next to the sampler was inundated and mud was found inside the rain gauge. Wires and connections were corroded and mud was found inside the box, as well as the power disconnect box on the tower at the station. This station will not be able to be salvaged and will need to be replaced.

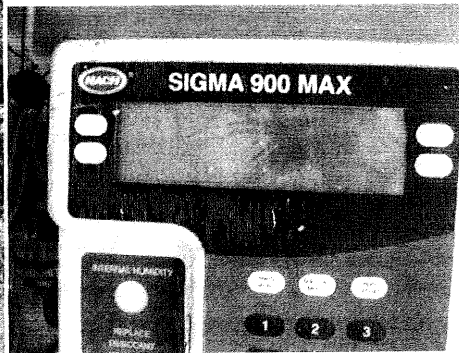
The Spencer Creek Station sustained major damage to the all-weather sampler. It was found down the hill from the original location, held in place by the power lines. Sampler lines and conduit were broken, and the all-weather sampler was submerged in floodwater from Spencer Creek. Water has entered the control head and the compressor, and it appears that it will not be able to be salvaged. The power instrumentation box on the back of the sampler was also inundated with water and all the electronics were exposed to creek water.

The bubbler at Spencer Creek was also damaged and does not appear to be working. The cell phone is operating. Although water entered the PVC enclosure, it appears as though it did not get high enough to damage the charger and the battery. We feel like this station is repairable, although the sampler will need to be replaced as well as the bubbler at this location.
